# Sediment Related Disasters Generated by Typhoons in 2004

**ABSTRACT:** In 2004, ten typhoons have attacked Japan islands of which 6 typhoons have generated severe damages onto Shikoku Island. This paper will feature the condition of the occurrences of sediment related disasters together with rainfall conditions. The disaster is divided into two types from the view point of mechanism; “Valley-off type debris flow” and “Gigantic slope failure which is controlled by the geological condition such as fault system or weathering of bed rocks during long time”. The former occurred in the area of rainfall less than 1,500mm/year, while the latter occurred in the area of rainfall more than 2,500mm/year.

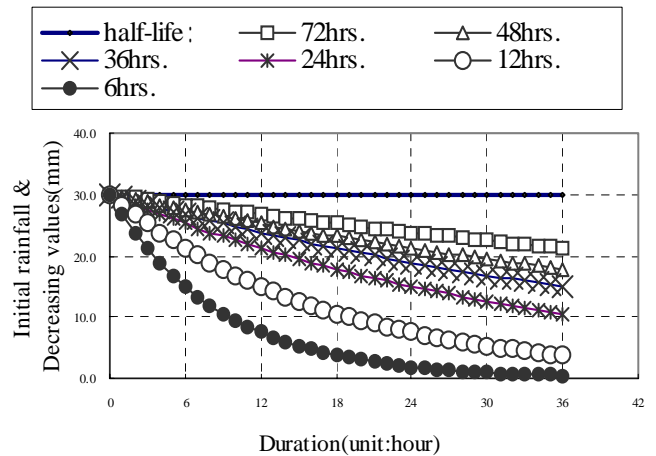
Figure 7 Initial rainfall and time dependent decrease of values according to the half life

here,  $h_0$  is the initial value of rainfall at an arbitrary time,  $\alpha$  is reduction coefficient and  $t$  is the value of half life. Figure 7 indicates how the initial rainfall will decrease under the condition of different half life. In case of the half life is infinite, as there is no reduction of initial height of rainfall during the run of time, thus rainfall remains its initial value.

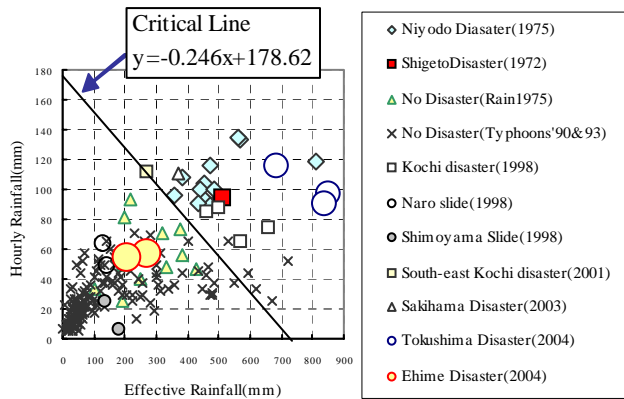
Figure 8 Critical line drawn according to the past rainfall data in Kochi during 1972-2003

Figure 8 indicates the relation of effective rainfall and hourly rainfall during 1972-2003 concerning the condition of the occurrences of sediment related disaster(Hiura, 1999). In case when disasters occurred, the abscissa indicates the cumulated effective rainfall of one hour before the occurrence of the event, while the ordinate indicates the triggering hourly rainfall. In case of non-occurrence rainfall case, the abscissa is the cumulated effective rainfall just one hour before the appearance of peak rainfall of a continuous rainfall.

As referred to in the preceding part of this paper, sediment related disasters often occur round the time when the intensity of rainfall becomes gentle, which is the time near the peak rainfall. The reason for the usage of effective rainfall of infinite half life is due to the convenience of treating and calculating rainfall data. The line drawn from upper left to the lower right on the figure is the critical line, and this line divides safety zone and dangerous zone from the occurrences of sediment related disasters. Thus, the upper right part of the line is dangerous and the lower left part is safe from the occurrences of the disasters.

The inclination of the critical line depend on the climate, topographical and geological conditions of the area and should be renewed by the occurrence of new disastrous event. On the figure, three point of Tokushima and two points of Ehime concerning the Typhoon disasters in 2004 are included. The points of Tokushima disasters are plotted at far right hand site on the figure 8, on the contrary points of Ehime are plotted to the lower left hand side in the safety zone together with points of Naro in 1998 and Shimoyama in 1998. Consequently, the area where the usual annual rainfall does not exceed 1500mm can not be discussed on the same diagram or same critical line. Though, for the case of Tokushima, points are plotted properly, though the magnitudes are far big.

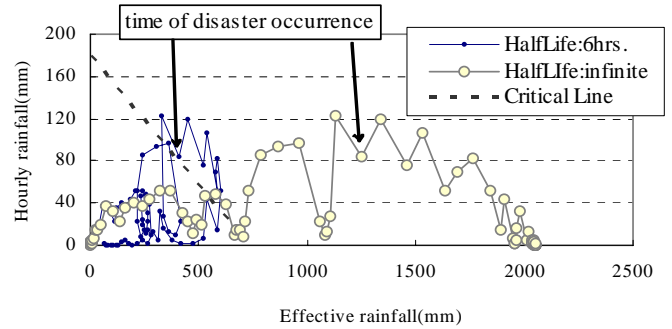
Figure 9 Snake lines of the Tokushima disaster in 2004

The snake line is drawn as follows; the abscissa is effective rainfall at an arbitrary time and the ordinate is subsequent hourly rainfall, connecting each point as time goes by, then the line similar to the movement of a snake is drawn on the diagram. This method is applicable during the rain is continuing and if the snake line goes close to critical line in the near future(2 or 3 hours later) , then the warning can be given or the preparation for the evacuation can be started. Two snake lines on the Figure 9 represent when the half life is 6 hours and infinite respectively for the case of Tokushima disaster in 2004. As a result, due to the high intensities of rainfall, snake line has been crossed in

the early stage of whole length of the rainfall (36 hrs. from the beginning of rain.

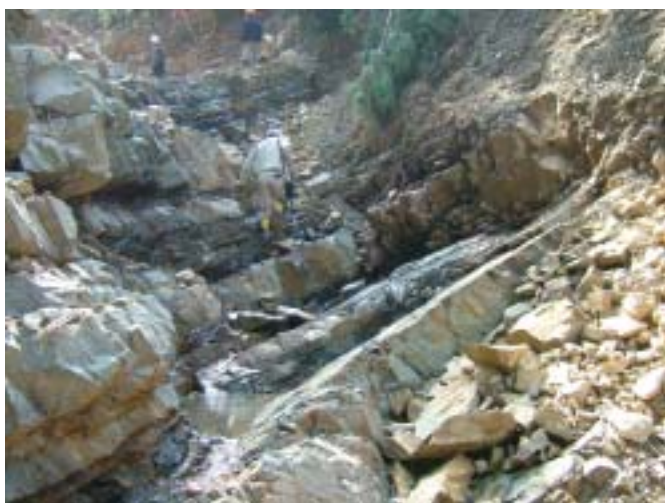
Photo 1 Upper reach of a valley-off torrent ( Niihama City, Ehime Prefecture )

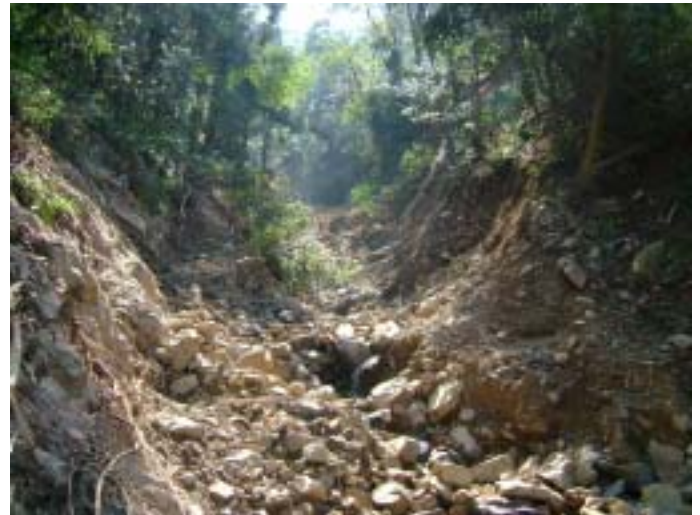
Photo 2 Middle reach of a valley-off torrent. Sand stone and mud stone alternate, all deposited sediment was swept away as the debris flow.ca.2-3m. Kike a big snake has gone away. Width: ca.4-5m. Depth of deposited debris

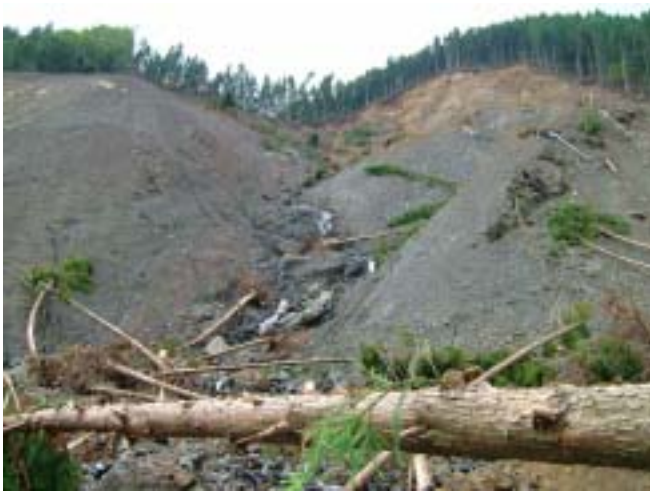
Here, two events will be introduced, the first is Kamagatani slope failure, and the second is Azue slope failure(Hiura *et al.*,2004). In both cases, the excess amount of rainfall has crossed the threshold and generated slope failures. And as shown in following two photographs(Photos 3 & 4), small torrents are seen which seem to have been existed before failure, thus there is a possibility that the slope movement was begun by the valley-off movement of deposited debris on the torrent floor, then due to the excess water provided by the overland flow and the underground water paths, slope movement has developed to become big. In case of Kamagatani slope failure, the moving soil mass was first moved onto the slope of the opposite side breaking two small check dams constructed in the valley of tributary, then turned to the right to the main stream and formed landslide dam for a while and the landslide dam was broken sooner after that.

Photo 3 Kamagatani slope failure. Length: 220m, Width: 200m, Mean thickness of superficial fallen layer: ca.5m, Mean inclination: 31degrees, Volume of fallen soil mass:ca.1.3×10<sup>5</sup>m<sup>3</sup>. Small torrent in the center of slope and spring point in the mid slope where the boundary of bed rock (weathered crashed muddy rock) and superficial thick layer

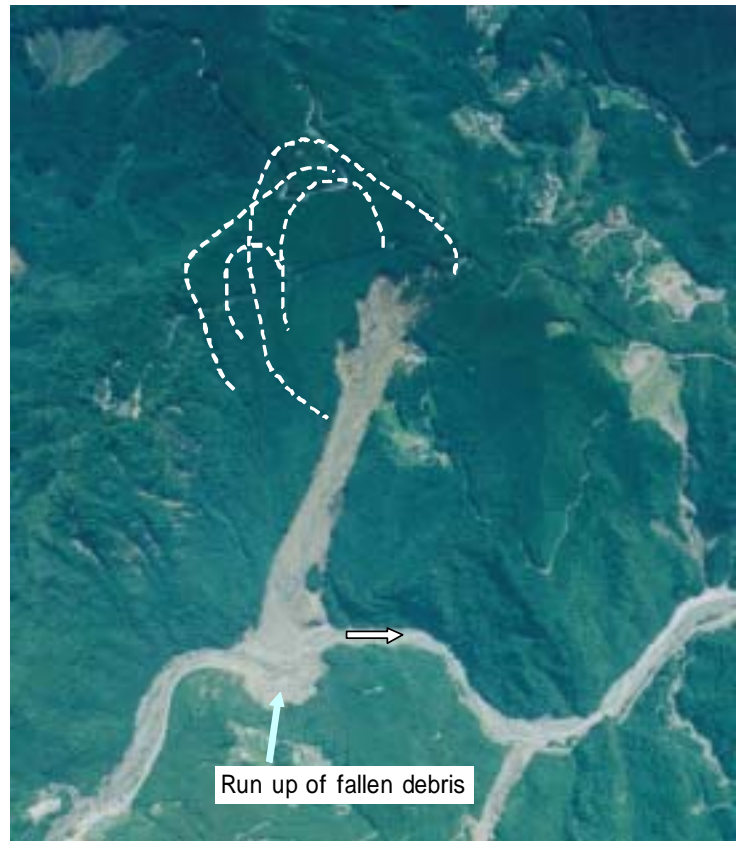
The second gigantic slope failure has occurred at Azue slope which is designated as deep slide area by the government. From the topographical point of view, the torrent flowing through the center of the fallen slope seems to have existed as well as the case of Kamagatani slope. Initially the slope was eroded at the foot by the River Sakashu-Kito and the unstable condition propagated retrogressively to the upper ward and at last whole slope has fallen. The maximum velocity of the moving soil mass was estimated to be 20m/sec according to the mark of splash of flowing debris. The liquidized water rich soil mass has run up on the opposite side of the River Sakashu-Kito

In the upper most area of Azue slope, the number of cracks was found which distribute to enclose the head scarp of the Azue failure. Among subsidence more than 2.5m within one month could be recognized. In Photo 4, cracks and subsidence found by the investigation in situ are indicated, thus the enlargement of these cracks and jointing each other to become continuous big cracks are worried to cause sever disaster in the near future.

Photo 4 Aerial photograph of Azue area just after the occurrence of slope failure.

Length:ca.1km, Width:100-300m, Thickness of fallen soil layer: 10-15m(upper slope), 5-8m(lower slope), Mean inclination: 20degrees, Volume of fallen soil mass:ca.1 × 10<sup>6</sup>m<sup>3</sup>. White dotted lines are cracks and/or subsidence recognized in situ.

from the present river water level to that of 20-30m above on the slope and dammed up for a while, and then the landslide dam was leached sooner by the increasing water level of main stream.
